**A Survey of Hydrological Systems in the Great Virunga Landscape:
Water resources assessment and use in and around Mgahinga Gorilla
National Park and Echuya Central Forest Reserve, S.W Uganda**

**Institute of Tropical Forest Conservation,
Mbarara University of Science and Technology**

February 2015

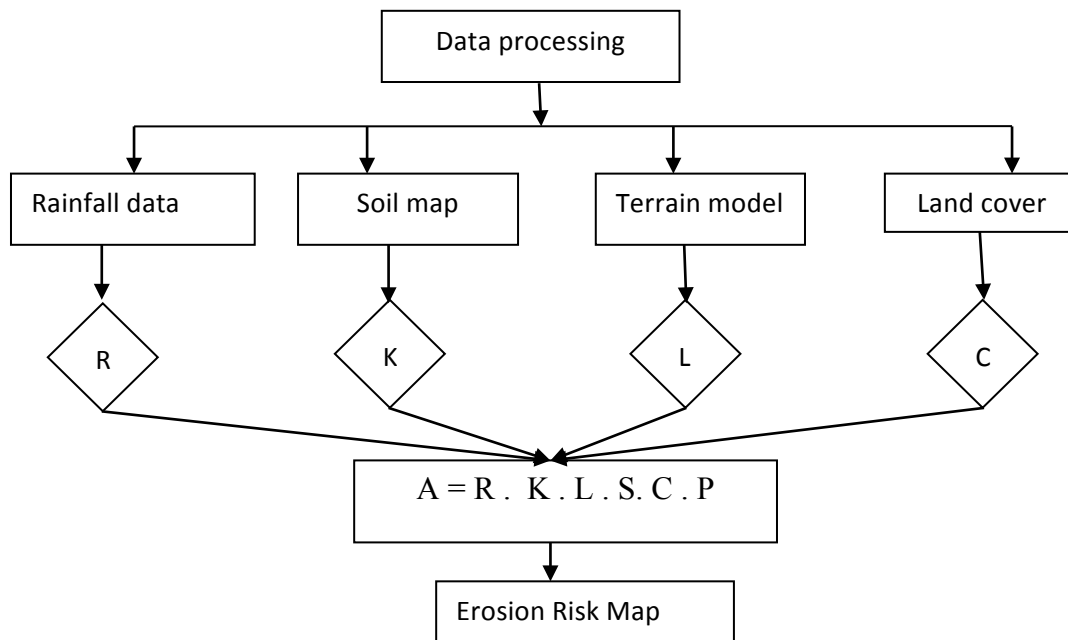
Figure 14. Flow chart for soil erosion mapping and risk assessment

After all the layers were computed for predicting the average annual soil loss, they were combined in the raster calculator in ArcGIS 9.3 (Figure 14), to produce a soil erosion risk map of the study area.

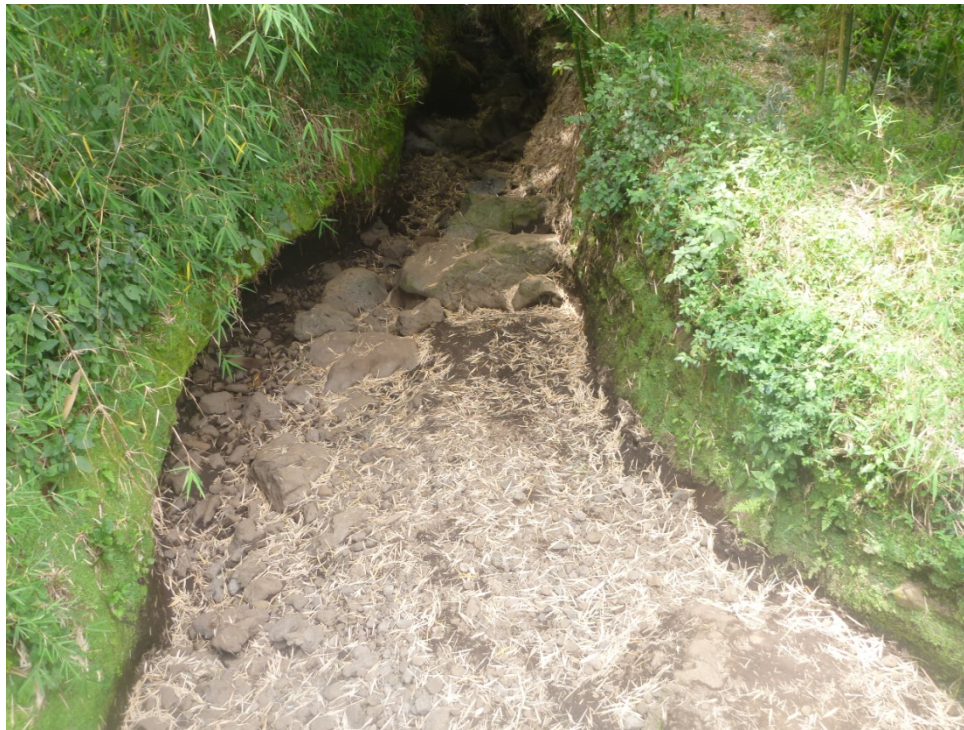
Plate 1: Ntebeko seasonal river water bed inside Mgahinga National Park, such rivers are important water sources for local communities especially during dry season spells

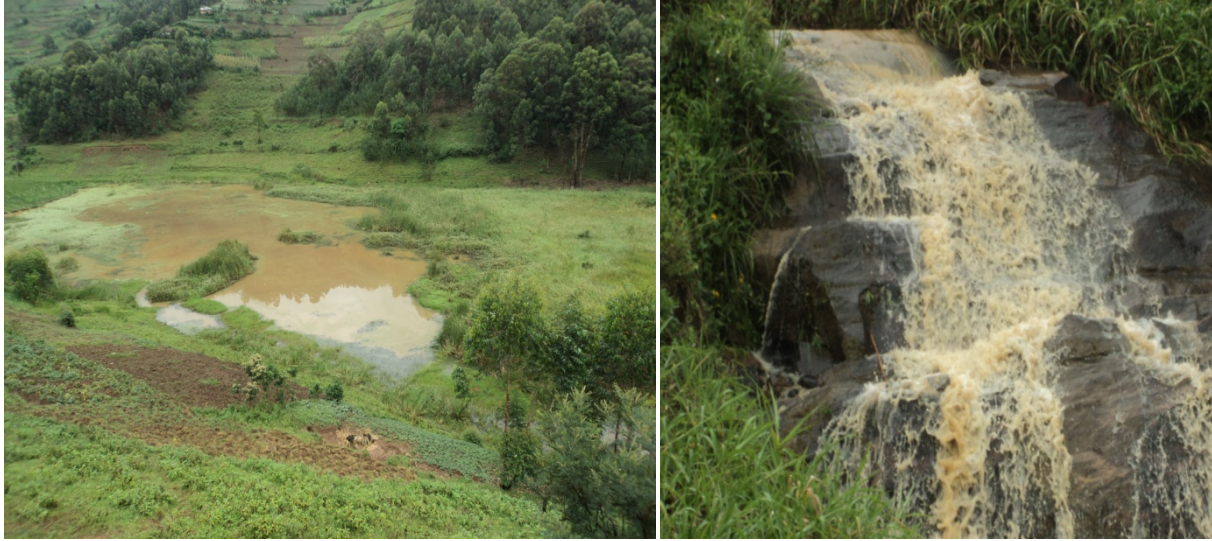
Plate 2: Water silting as a result of soil erosions and floods around Echuya forest

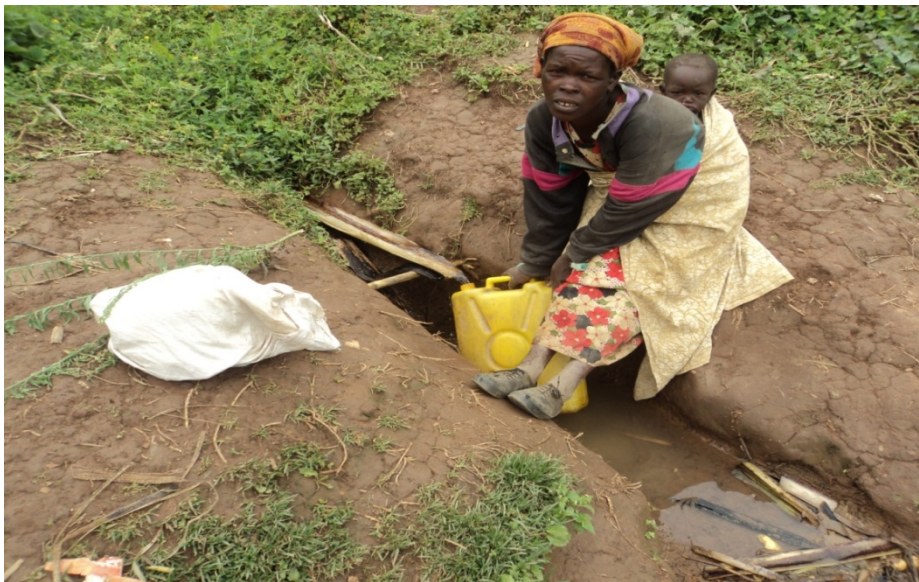
Plate 3. An example of a poor water source (seasonal) near Echuya forest.

- Poor quality of some water sources (with dirty water)
- Insufficient water supply at some water points,
- Limited water harvesting containers
- Competitions of water on some water points by humans and livestock
- Long spells of dry seasons that lead to drying up of some water sources, it was reported that water levels go very low during dry seasons that most water sources and points drying up in the month of July.
- Increased human populations that have increased the demand for water yet water supply is reducing

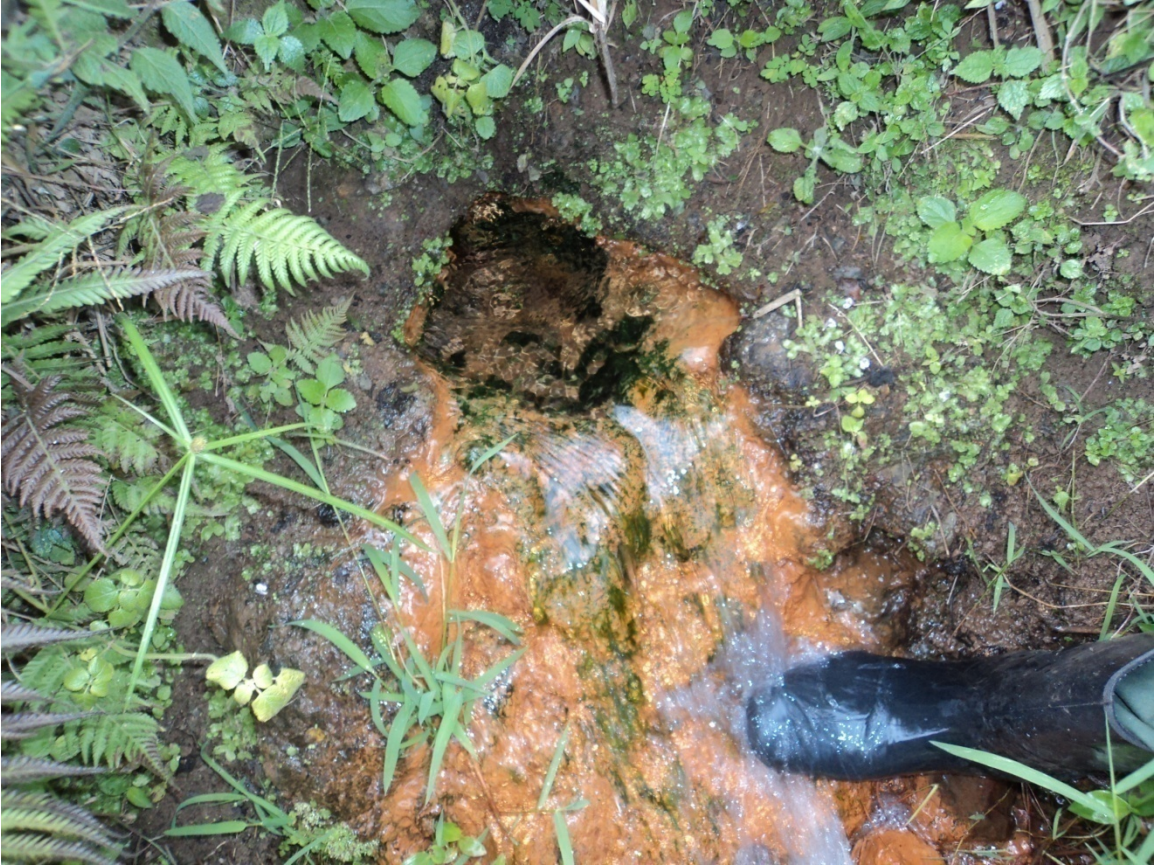
Plate 4. Unprotected water spring in Echuya (note the clear water with algal growth and the brownish colour due to iron oxides at the basement, this can be dangerous for human use)

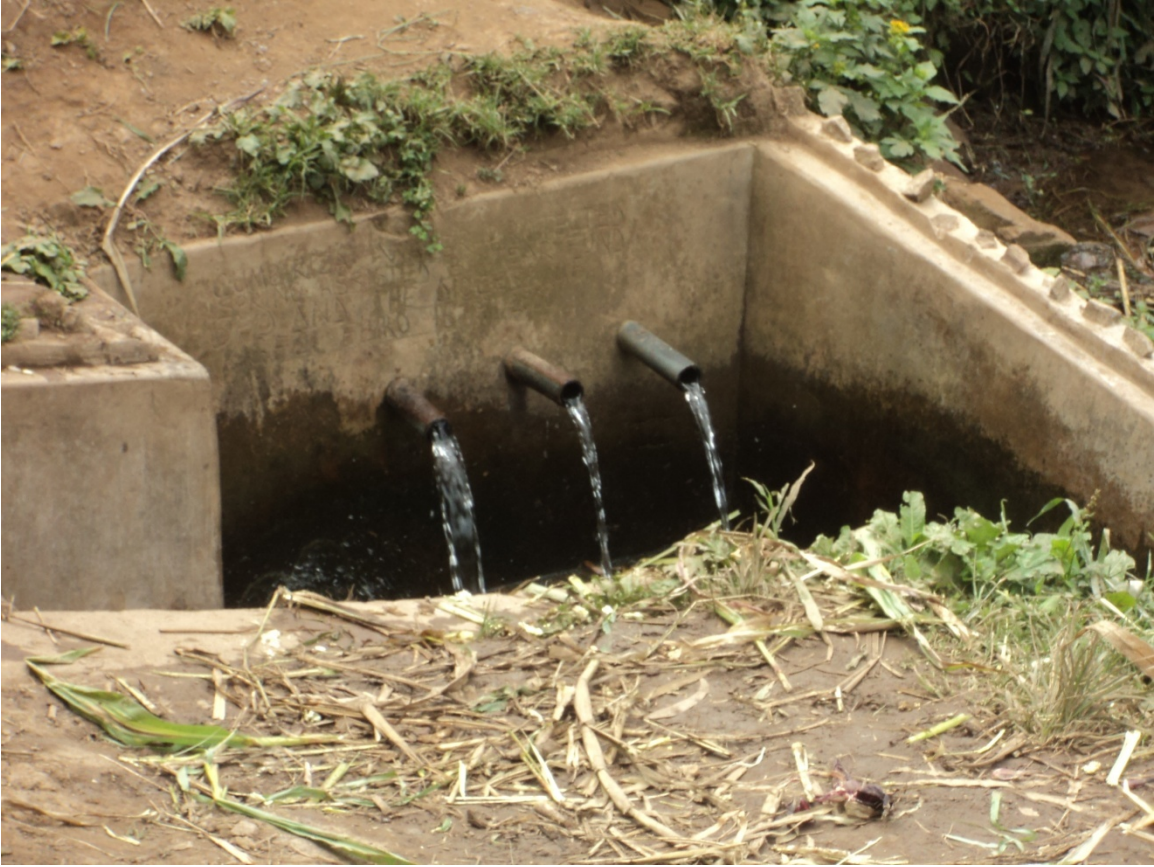
Plate 5. A protected water spring with three barrels. Note the clear water and the varying flow volumes in the different pipes

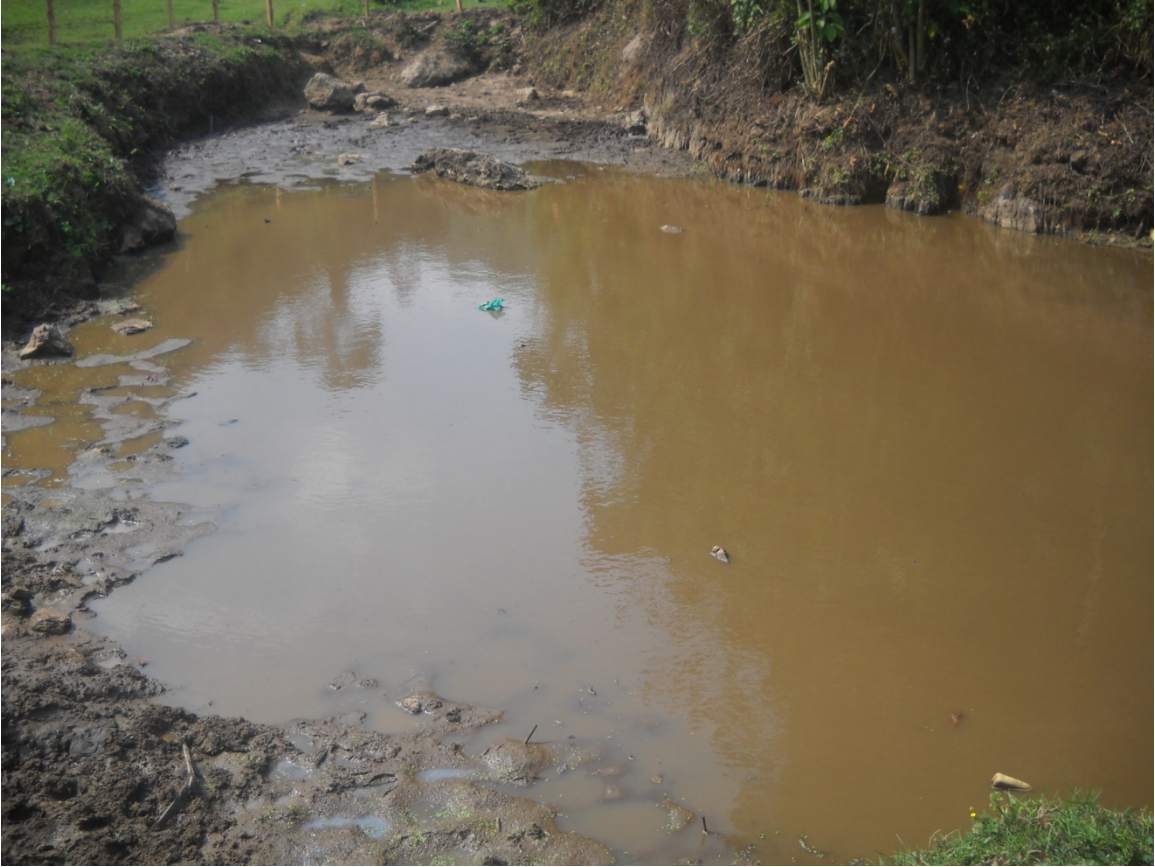
Plate 6. Mukashayo water dam near Echuya forest; this photo was taken during the dry season

Dams are man-made constructions usually containing rainwater and are used mostly to water livestock and irrigate crop fields. Dams were few or none in some parishes such as Kacherere and Kashasha but tended to increase in water-scarce parishes such as Karengyere and Muhindura (Figure 52). They are also called reservoirs and retain water during wet seasons and the water is mostly used during the dry seasons. Plates 6 and 7 show the seasonal changes in water quality and quantity at Mukashayo dam in Kalengyere parish. Ponds are natural depressions in the drainage system where the water table is low, thus supplying water from underground sources. Pond numbers were low in most parishes ranging from none in Muhindura and Karengyere parishes to 10 in Kagezi parish. Ponds are normally used for watering animals but during time of scarcity, the water may be consumed domestically as was witnessed in Karengyere parish.

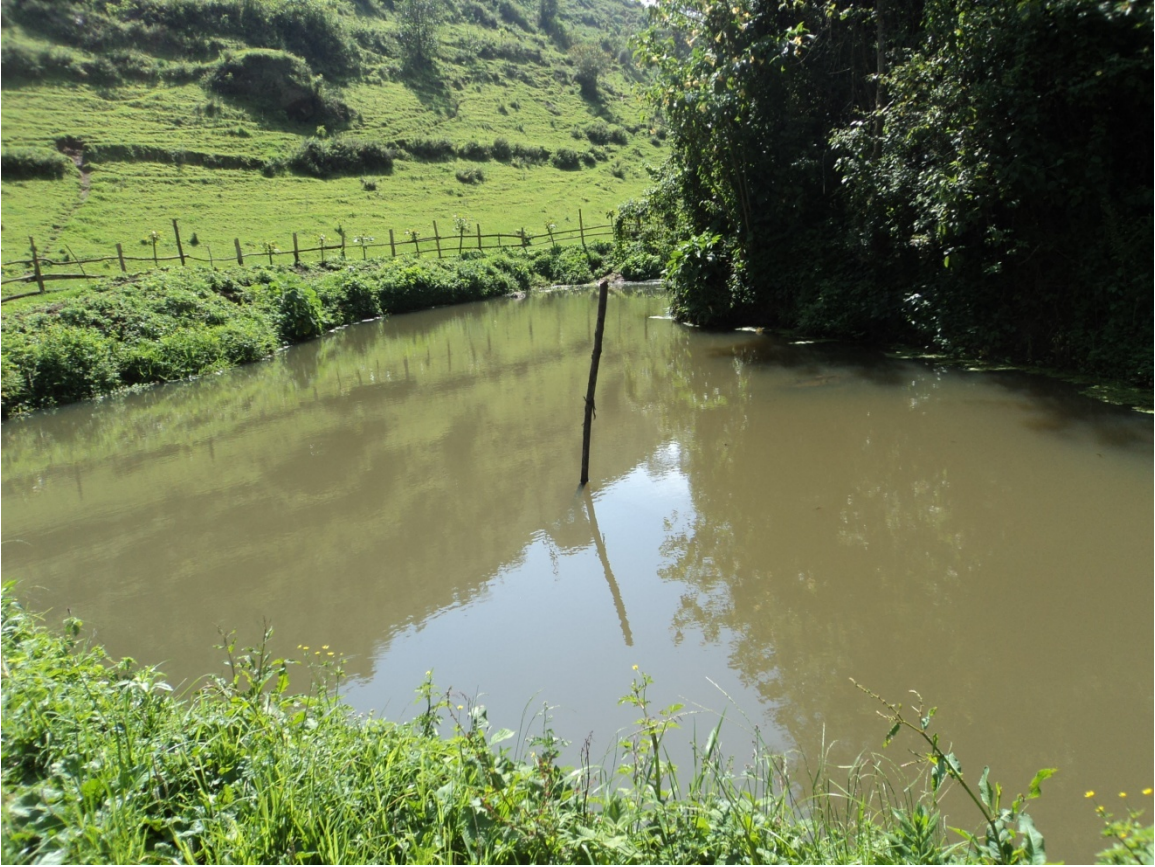
Plate 7. Mukashayo water dam near Echuya forest; this photo was taken during the wet season

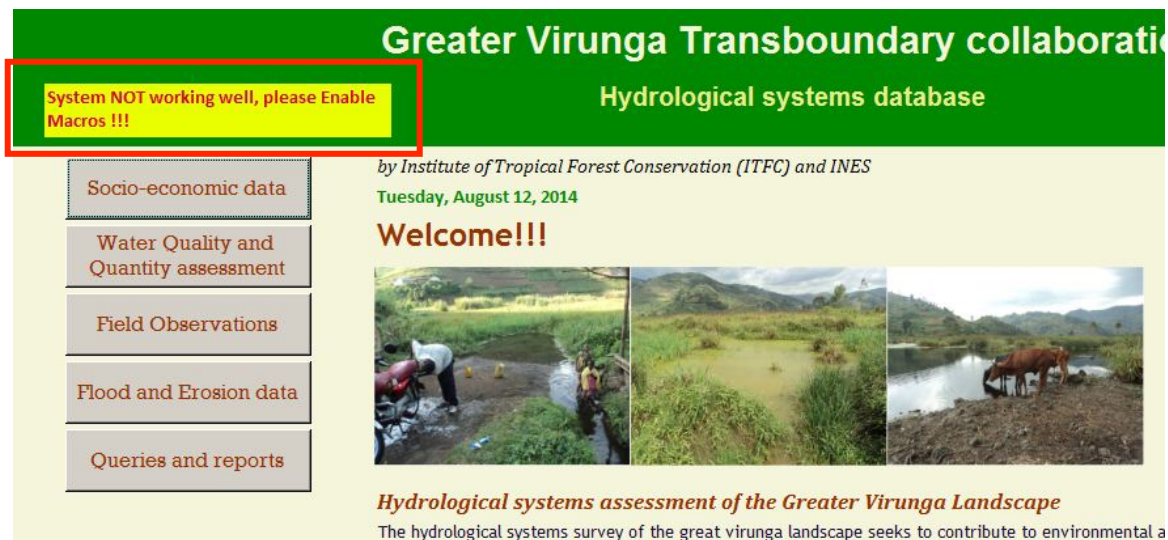
If macros are disabled and you start the system, it will display a warning message in yellow, reading “System NOT working well, please Enable Macros”. See illustration below:

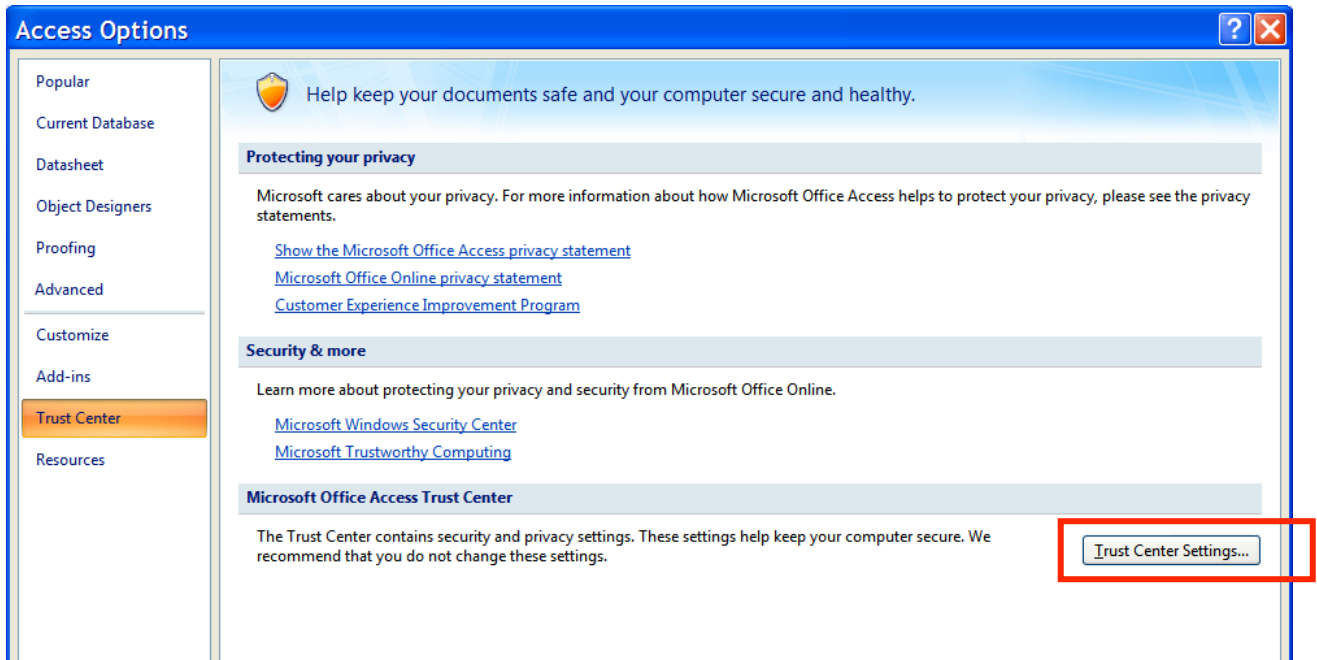
In the menu displayed on the left side of the dialog box, search for a button labeled “Trust Center” and click it. This will display the “trust center” dialog box. This dialog box is used to set the trust level, which determines whether the system should trust code and macros, basing on the criteria set.

Click the button labeled “Trust Center Settings” in the lower right corner.
