Implications of Land Use and Cover Changes on Upper River Rwizi Macro-Watershed Health in South Western Uganda

Denis Nseka, Hosea Opedes, Frank Mugagga, Patience Ayesiga, Henry Semakula, Hannington Wasswa and Daniel Ologe

Abstract

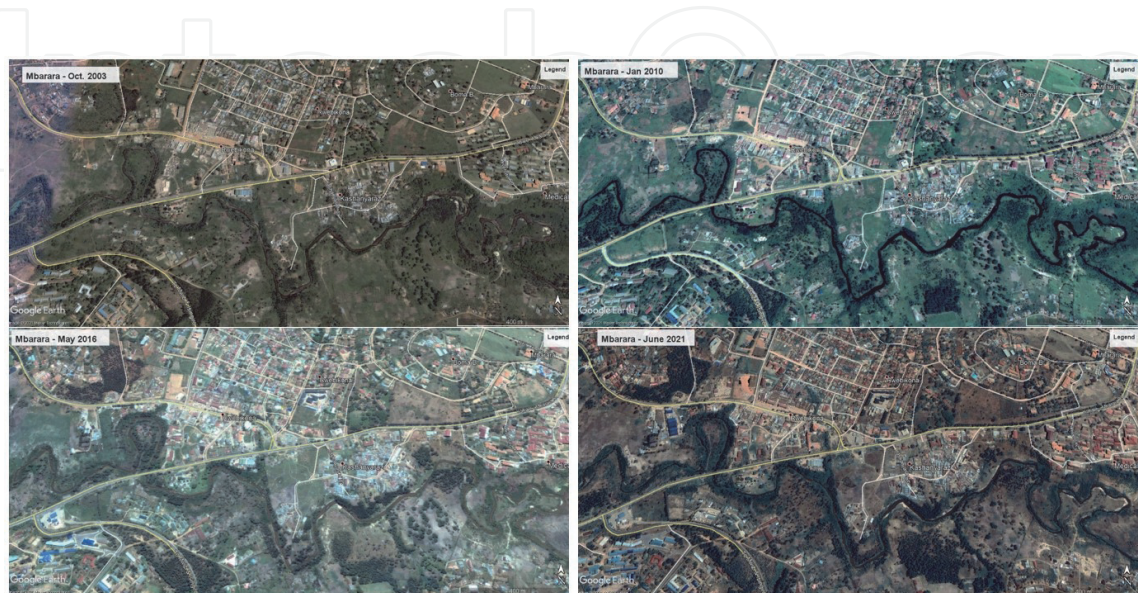
Figure 7.
Land use and land cover distribution between 2003 and 2021 based on Google earth images for a section in Mbarara City.

The study area has experienced a drastic conversion from natural land covers especially grasslands and forests to human dominated covers including farmlands and settlements over the past 30 years and more (see Google earth images in **Figure 7**).

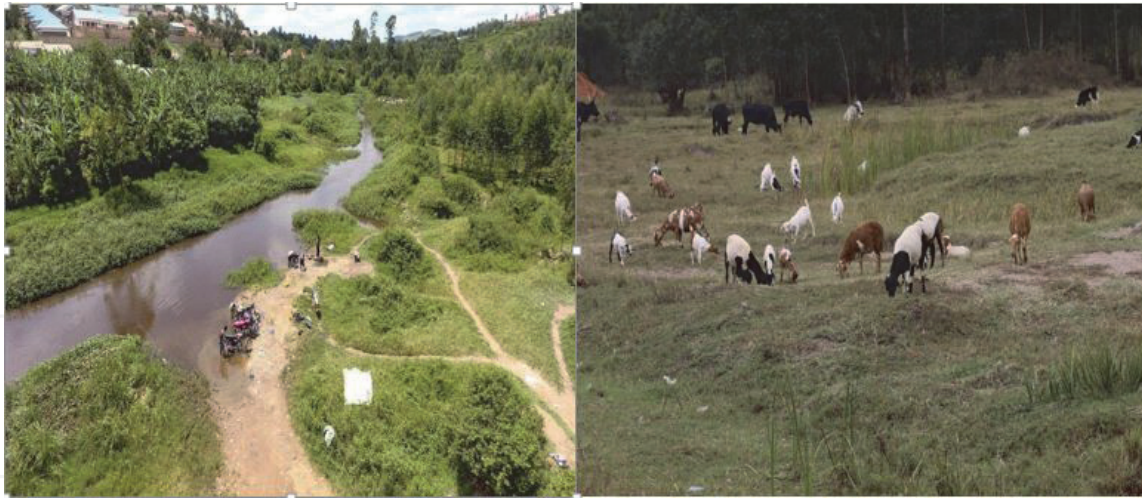
Figure 8.
Farming activities along Rwizi river buffer zone. Photo credit, Ayesiga, March, 2021.

The observed farming practices in the study area include both arable and livestock farming. Whereas arable farming is dominant in lowlands and middle slope elements, livestock is commonly practised in the upper slope sections. The major crops grown include both perennial and annuals. The perennial crops include bananas (*Musa paradisiaca*), coffee (*Coffea spp*), tea (*E. abyssinica*), sugarcane (*S. officinarum*) and mangoes (*M. indica*) grown for commercial purposes. The annual crops include Irish potatoes (*Solanum tuberosum*), sweet potatoes (*I. batatas*), maize (*Z. mays*), beans (*P. vulgaris*), peas (*P. sativum*), finger millet (*Eleusin coracana*) and vegetables. In most cases, the crops are inter-cropped. For example farmers inter-crop annual crops in banana gardens especially during the wet season. The dominant cropping systems in the watershed is banana/coffee system.

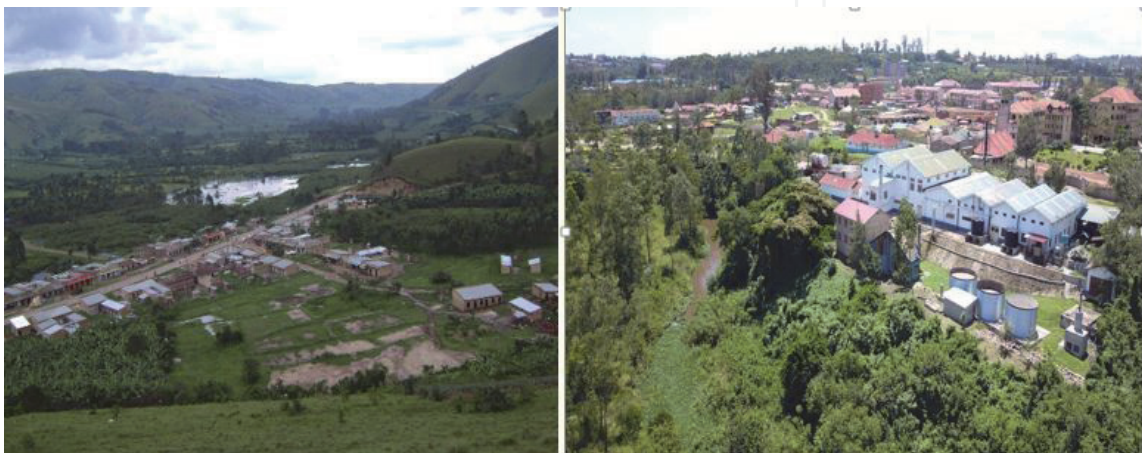
Figure 9.
Urban settlements along Rwizi river valley and buffer zone. Photo credit, Ayesiga patience. August 2020.

The study area has experienced increased population growth with a population density of 361/km² [23]. The high population growth in the upper river Rwizi macro watershed has led to establishment of several settlements of both rural and urban setting (**Figure 9**). In the study area, settlements are dominant in the valley bottoms and lower slope elements (**Figure 9**). This has led to establishment of roads, buildings and installation of various utilities such as power transmission and telecommunication lines (**Figure 9**).

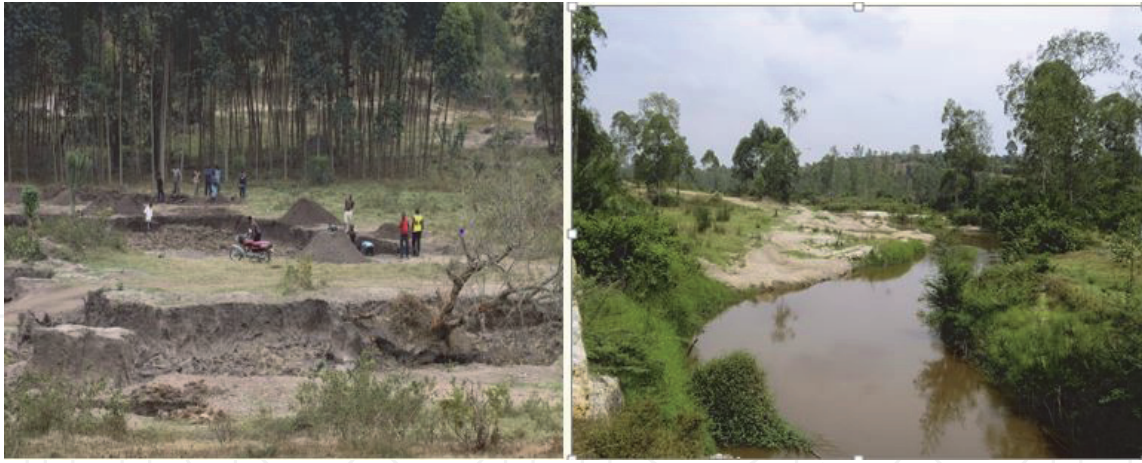
Figure 10.
Sand mining close to river Rwizi near Mbarara City and Rwizi's buffer zone in Nyakayojo. Photo credit, Nseka, December 2020.

Due to rapid urban development in the region, there has been an increase in demand for construction materials including sand and bricks. In order to meet the demand for construction materials, local communities have embarked on sand mining (**Figure 10**) and brick making (**Figure 11**) along the riverbanks, wetlands and buffer zones.

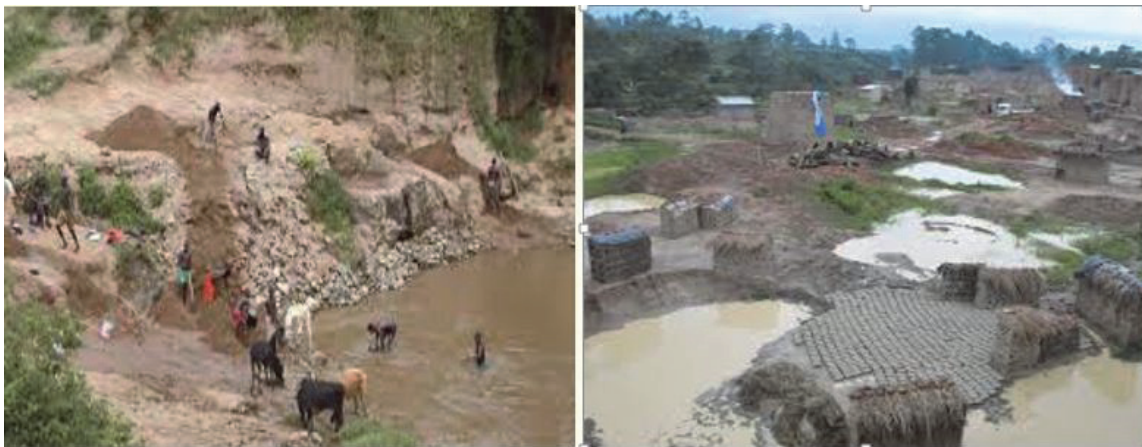
Figure 11.
Brick making site near Ruti in Mbarara City and Nyaihanga in Rwampara Distrct. Photo credit, Ayesiga, February 2021.

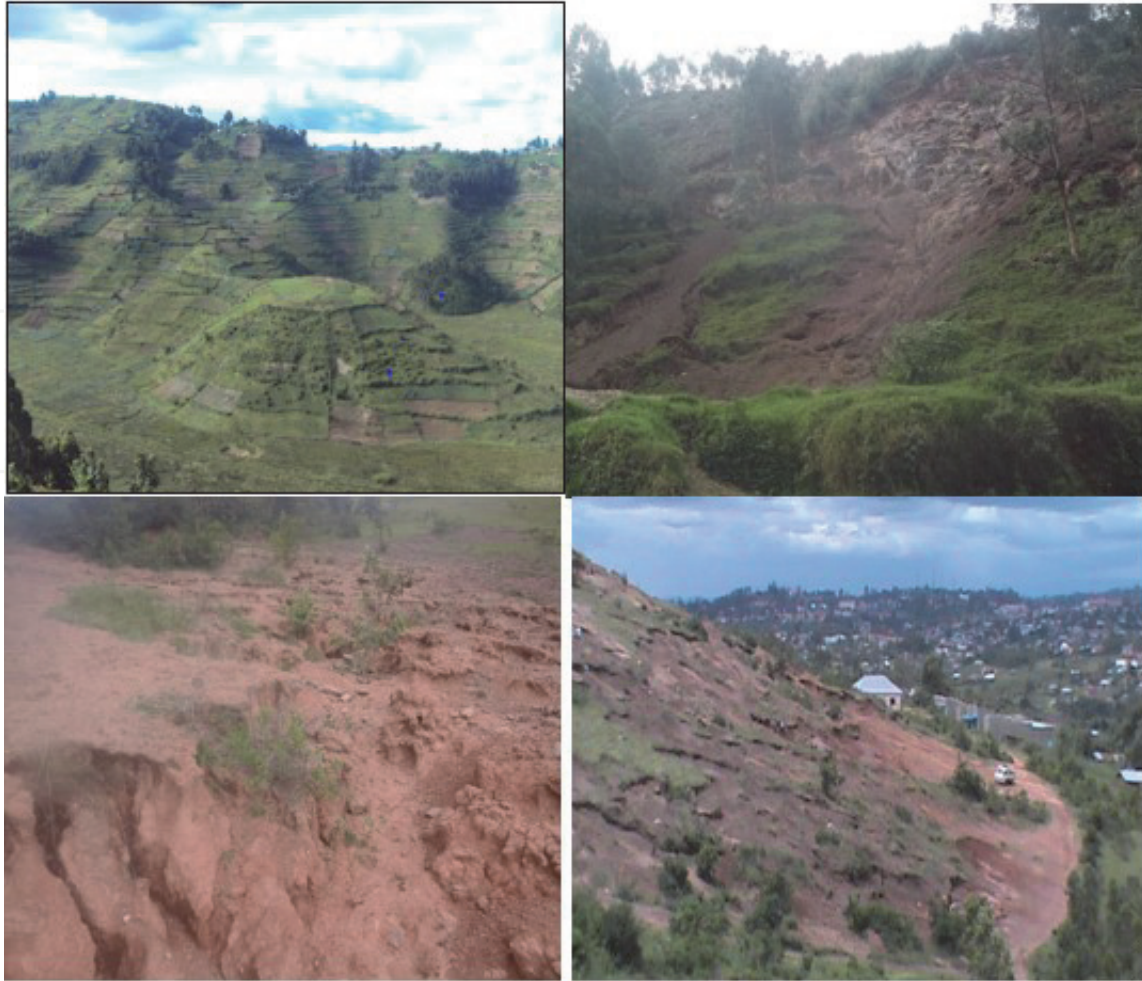
Figure 12.
Intensively cultivated slopes which appear to be degraded. Photo credit: Nseka, July 2020.

Changes in the land use and cover characteristics associated with increasing human activities have adversely affected the watershed properties. As already noted, there has been unprecedented conversion of natural land covers into human induced types. Following field investigations, it was established that many slopes flanking the river valley appear to be intensively cultivated leading to the emergence of many bare surfaces (**Figure 12**). Increased farming activities have affected

hillslope hydrological properties. This has resulted into increased runoff due to reduced infiltration as evidenced by many gullies and other erosion features on the landscape (**Figure 12**).

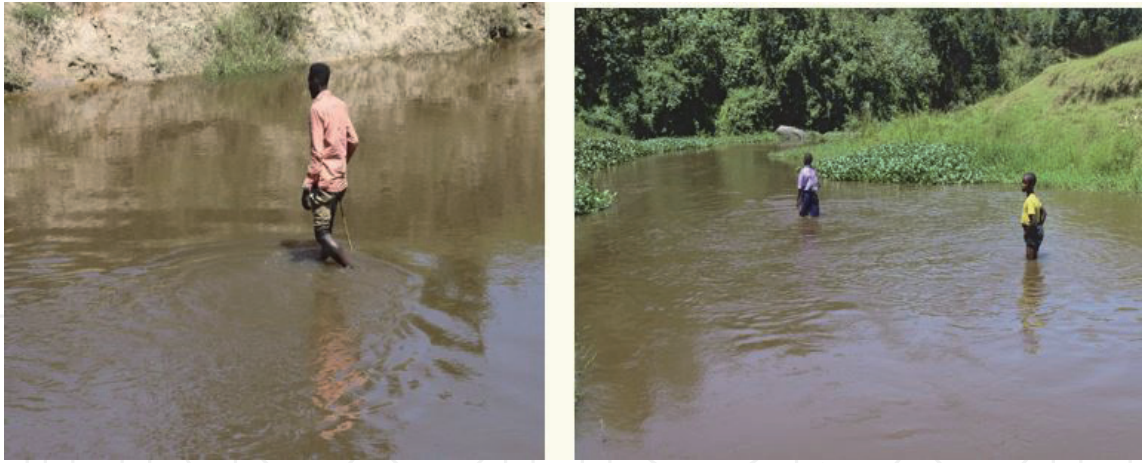
Figure 14. Shallow section of the river channel where local communities cross without bridges. Photo credit, Ayesiga, September 2020.

(**Figure 15**). Communities living in the watershed revealed that memories of the river with its ample clean water, thick vegetation, wild animals and birds are quickly fading. A close observation of the river channel indicates higher levels of turbidity, with the channel water turning to brown (**Figures 14–16**).

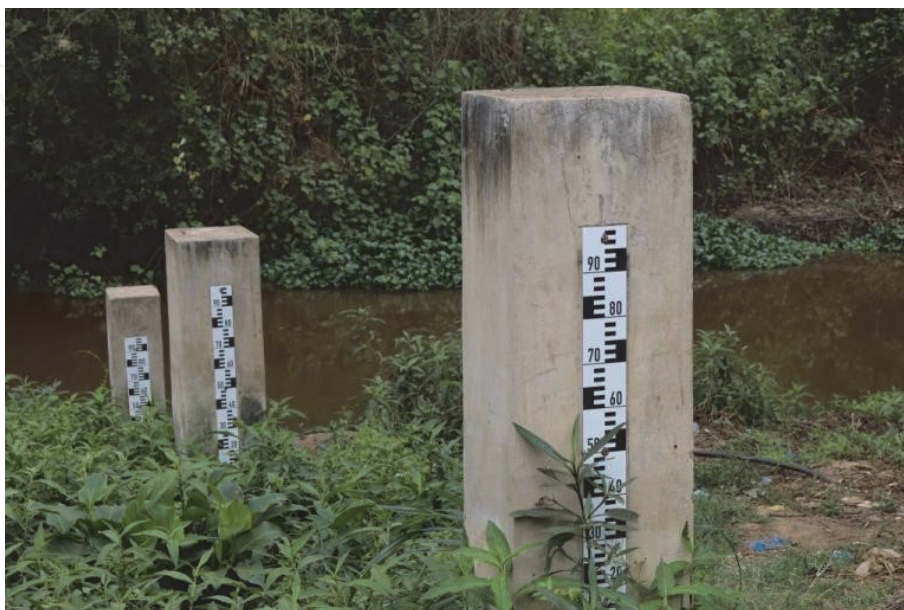
Figure 15. The river’s water flow gauging station near Nyamitanga in Mbarara town has been rendered useless. Photo credit, Ayesiga patience, October 2020.

coming years if nothing is done to save it. During interactions with local communities, it was further reported that “the formerly wider river is narrowing”. Sometimes, during the dry season, since there is hardly any water flowing from the hills, the water levels reduce into a small stream and, if one is not keen enough, they would think it is not a major river. Local communities indicated that sand mining and brick making along the riverbanks and its buffer zone have almost changed its course. Farming and sand mining are among the most destructive activities choking river Rwizi to extinction. Due to increased human activities along the river valley, compounded with wetland and swamp destruction, the water levels in the river channel and its tributaries have drastically reduced. This is vividly evidenced by the river’s water flow gauging station that is no longer used to monitor flow dynamics (**Figure 15**).

Following field investigations as well as interaction with local communities and key informants, it was established that the water levels of river Rwizi has dwindled by two and a half meters from the highest level where it used to be as indicated by the original gauging pillars at Nyamitanga which were established in 1970

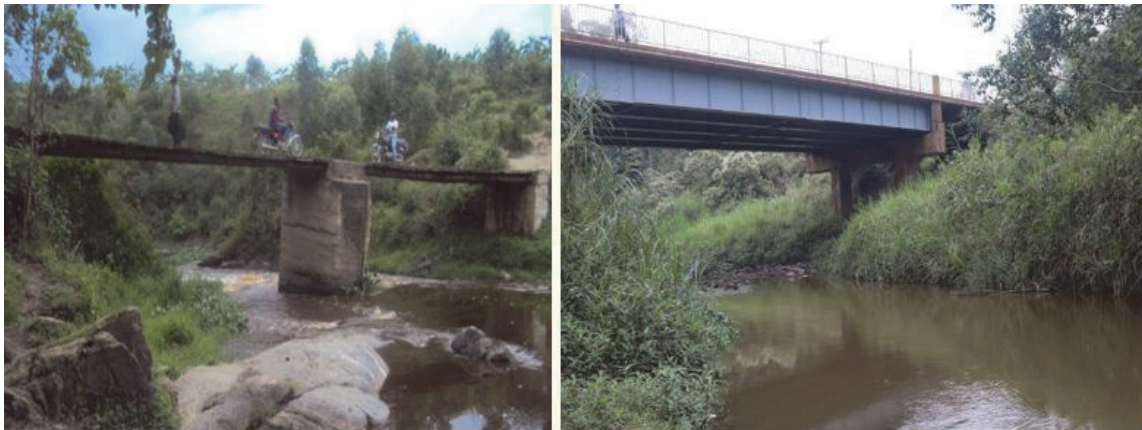
Figure 16.
Dropped water levels along sections of the river Rwizi. Photo credit, Ayesiga patience, December, 2020.

High levels of deposition were also evident in the form of pebbles, silt and clay on the riverbed that has been exposed following low water levels and subsequent reduction in water flow velocity as observed below Rubaya bridge along Buremba road and Ngaromwenda bridge on the Mbarara-Kabale highway (**Figure 16**). The drop in water levels is turning away investors whose project's lifeline depends on good volume of water in the Rwizi river. The drop in water levels is most likely, linked to the degraded hillslopes that no longer have the capacity to recharge the river system.

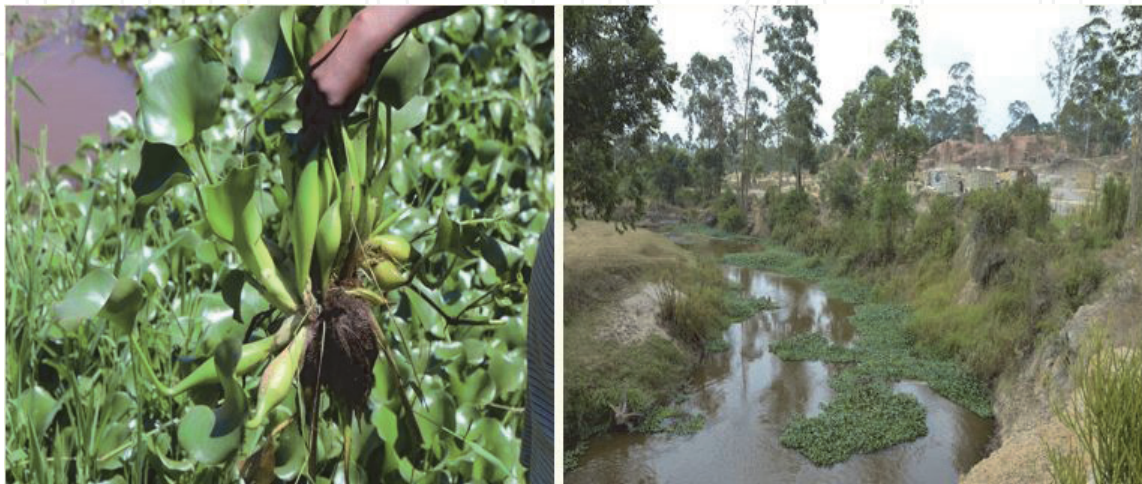
Figure 17.
Sections of the river invaded and covered by water hyacinth near Mbarara City. Photo credit, Nseka, December 2020.

Due to continuous watershed degradation, many sections of the river channel have been invaded by the waterweed (**Figure 17**). The invasive water hyacinth has congested the river, right from Ndeija sub-county in Rwampara District up to Sango bay in Rakai and the problem has been exacerbated by destructive agricultural practices within the watershed.

The water hyacinth is an indicator of polluted water with many nutrients from the surrounding gardens. Following an interaction with communities, it was revealed that the river's deterioration is due to widespread illegal land grabbing along the fragile riverbanks and buffer zone.
