Implications of Soil Properties on Landslide Occurrence in Kigezi Highlands of South Western Uganda

Denis Nseka, Vincent Kakembio, Frank Mugagga, Henry Semakula, Hosea Opedes, Hannington Wasswa and Patience Ayesiga

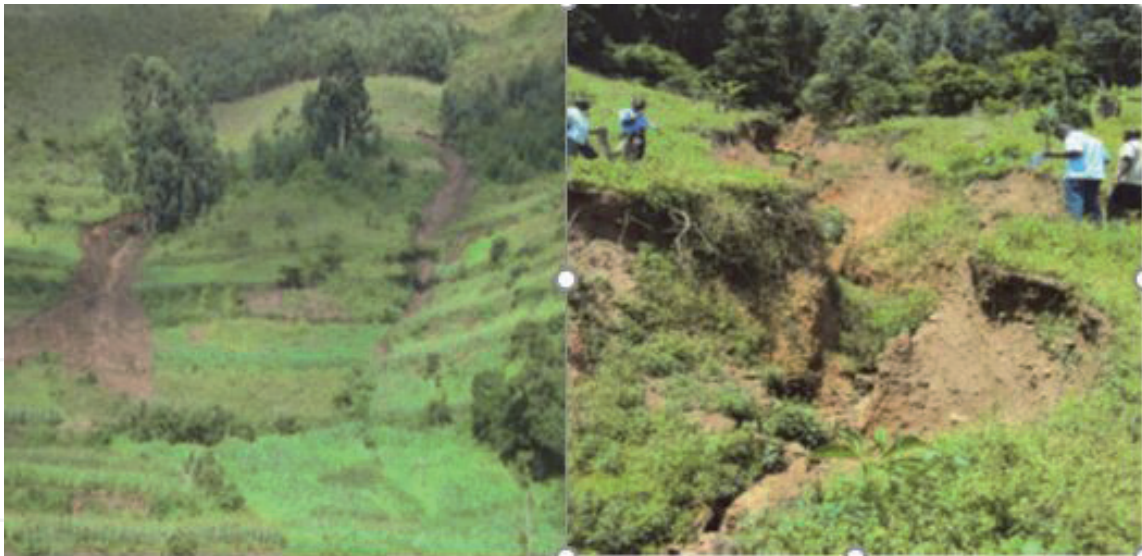
Figure 2.
Field investigations to identify landslide scars and soil sampling. Photo credit, Nseka. November, 2019.

The study was carried out in Rukiga uplands located within Kigezi highlands of South Western Uganda. The study area is situated between 01°21'25" and 0°58'08" South, and 29°43'30" and 30°05'51" East (**Figure 1**). Rukiga uplands an area covering 427 km² [20], span the attitudinally heterogeneous landscapes of Rwamucucu, Maziba, Kashambya, Bubaare, Bukinda, Kamwezi and Kaharo [21] was selected for this study on the basis of its unique topography which is synonymous with reported high incidences of landslides, with visible scars unlike other parts of the highlands where landslide scars have been concealed owing to rapid regeneration [22]. The topography is very rugged, with narrow steep convex slopes and high valleys between hills. Most of these valleys have drainage lines connecting to the main valley [23]. The topography has substantial flat-topped ridges and hills, with short, steep-sided deep valleys fragmented by fluted spurs [24]. Landslide scars were, therefore, identified following an inventory with the help of local communities (**Figure 2**). The landslide scar zones provided soil sampling sites for analysis of soil characteristics and their influence on landslides (**Figure 3**).

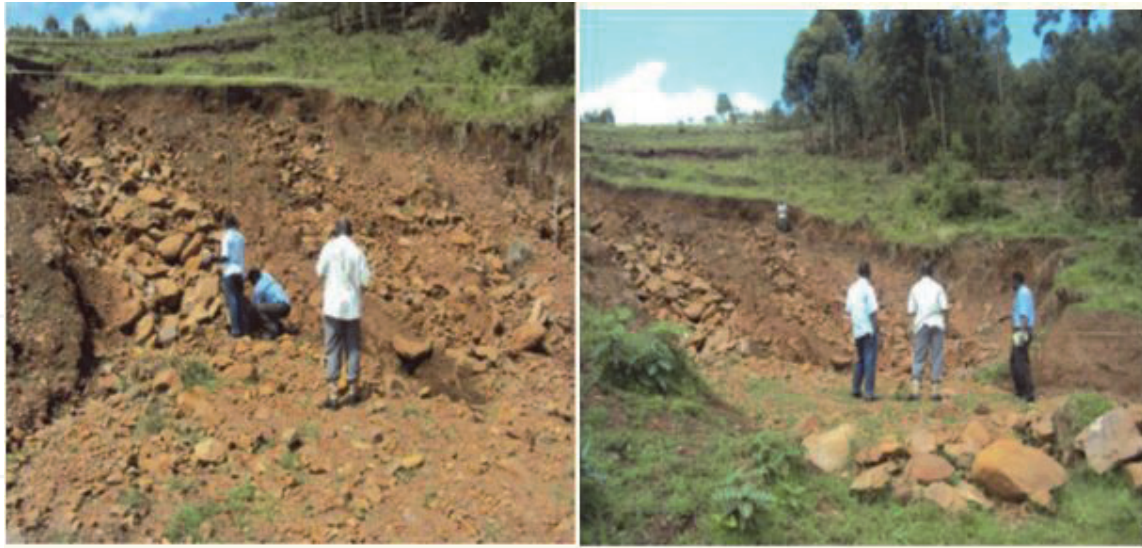
Figure 3.
In-situ soil property analysis within the landslide scars. Photo credit, Nseka. November, 2019.

Profiles in the upper slope sections were dug to a depth of 1 to 1.5 m (classified as shallow). Profiles in the middle slopes ranged between 2 to 4 m (medium) while those in the lower sections were greater than 5 m (deep). Soil samples were obtained from within and outside the landslide scars. Onsite analysis of physical soil properties was conducted within landslide scars, min pits, auger holes, and full profile representative sites (**Figure 3**). Site analysis sought to characterise among

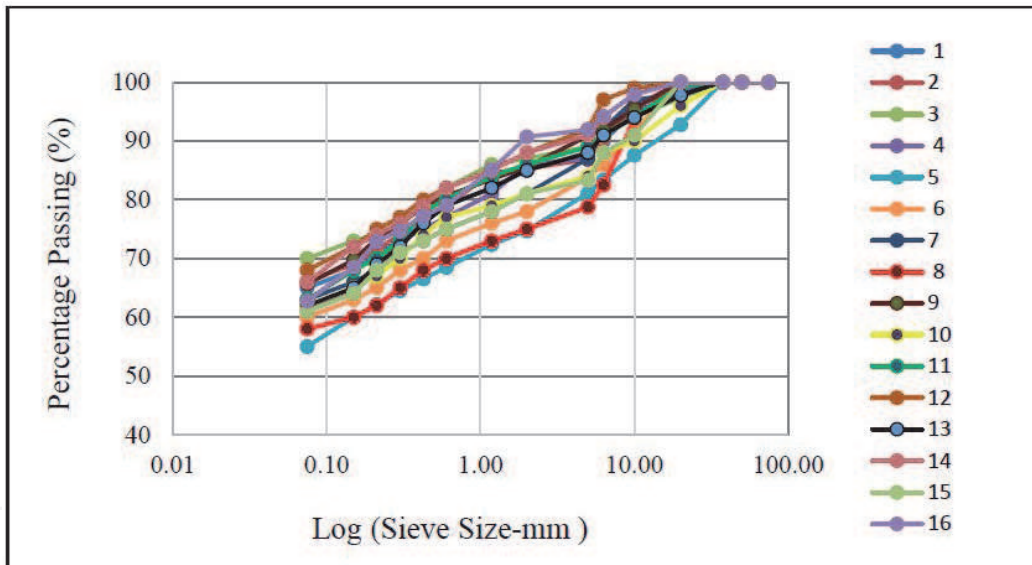
Figure 5. Particle size distribution curves.

The study area is dominated by clay soils in the subsurface horizons. The particle size determination (**Figure 5**) shows that soils are dominated by clay presence, except for the uppermost surface horizons.

From the materials analysed, fine grained materials of either clay or silt were predominant (**Figure 5**). The texture of the soil varied with profile depth as

revealed by sieve analysis. In the subsurface horizons, finer clay and silt materials dominates, while sand particles are the most dominant in surface soils. It was observed that all surface horizons had sand (33–55%), silt (22–40% and clay (10–30%). In the deeper horizons, sand was observed to reduce drastically to less than 23%, while clay increased to greater than 50% (Appendix 1). The clay content for all the samples in the sub soil and deep soil horizons is well above the 32% threshold for vertic soils. The swelling and shrinkage characteristics of vertic soils are very important in the localisation of landslides, as explored in the subsequent section.

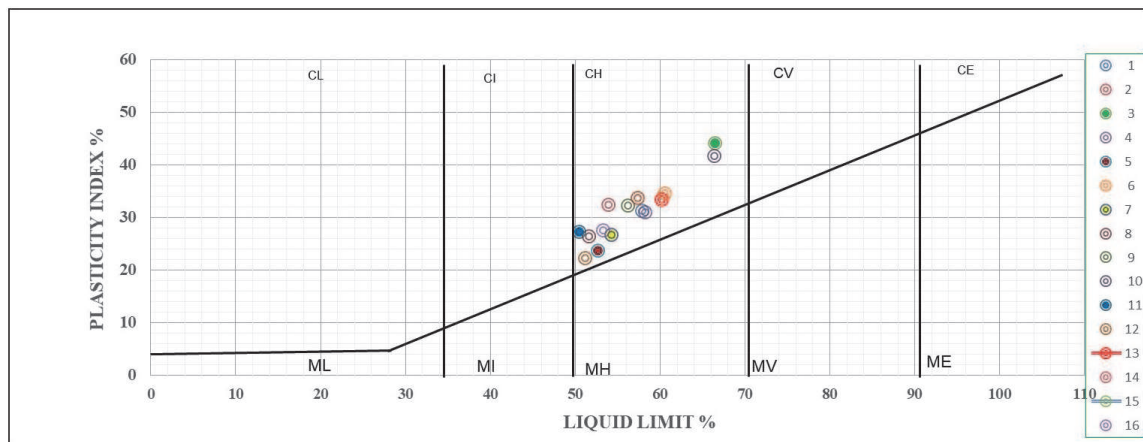
From the plasticity chart (**Figure 8**), all the soil samples tested were inorganic clay of high plasticity belonging to the CH group. Such soils can easily move when saturated, leading to a high incidence of landslides.

From **Figure 8**, it is evident that soils in the study area have high plasticity as already revealed by XRD results. Such soils can easily move when saturated, leading to high incidence of landslide occurrence. The presence of many cracks, observed on the soil surface during field investigations confirms the high plasticity nature of the soil materials (**Figure 9**). The presence of such cracks on the surface is also a characteristic of Vertisols with high expansive potential.

Figure 8.
The distribution of samples on the plasticity chart for the USCS.

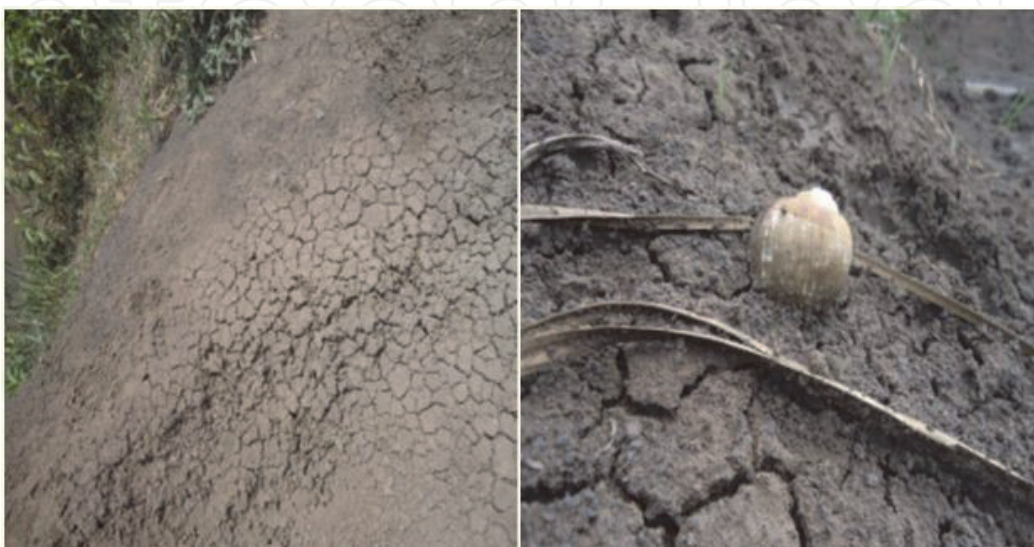
Figure 9.
Highly expansive materials with numerous surface cracks. Photo credit, Nseka, march 2019.

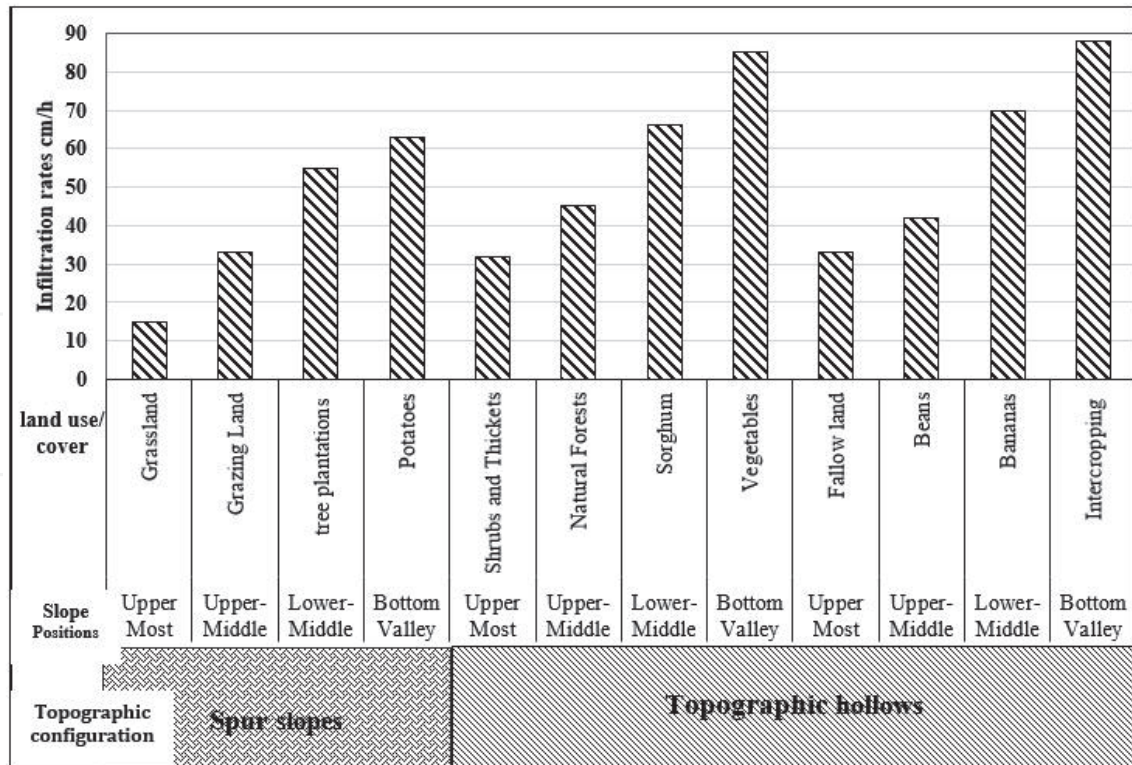
Figure 11.

High infiltration rates were observed in the top soils with depth ranging from 0.3 to 0.8 m, but drastically reduced in the sub soils. Steady infiltration rates greatly varied with topographic characteristics and land use/cover types. Higher infiltration values were noticed in the lower slope elements than the upper sections (**Figure 11**). From the infiltration experiments conducted, it was revealed that the average soil-water infiltration was 24 cm/h^{-1} in uppermost slope sections. On the upper-middle, lower-middle slope sections and bottom valleys, soil-water infiltration rates of 30 cm/h^{-1} , 70 cm/h^{-1} and greater than 80 cm/h^{-1} respectively were achieved from the experiments conducted. Along the hollows within the upper slope sections, the

Infiltration rates along slope positions, topographic configurations and land uses/covers.

observed infiltration rates were greater than 30 cm/h^{-1} and less than 12 cm/h^{-1} along the spur slope sections. Whereas the infiltration rates within topographic hollows along the middle slope sections was greater than 70 cm/h^{-1} , it was less than 45 cm/h^{-1} on the spur slope elements (**Figure 11**). Within the top soil layers, high infiltration rates are explained by the dominance of loamy sandy soils. The predominance of clay materials in the subsoil, with claypans distinctly underlying the top soils, limits water infiltration in the study area. Such soil characteristics affect their response to incoming rainfall and consequently the timing of landslides, as explored in the discussion section.

The land use and cover characteristics influence soil water infiltration in the study area. Within the agricultural land uses particularly along cultivated zones, infiltration rates were noticed to be higher than those observed on natural land cover types. The infiltration rates along the agricultural land uses were generally greater than 65 cm/h^{-1} with the exception of beans covered areas where infiltration rates were noticed to be lower than 42 cm/h^{-1} . On the natural land cover types including grasslands, thickets and shrubs, infiltration values lower than 30 cm/h^{-1} were generally observed (**Figure 11**). Areas covered by forests, however, tended to have infiltration values higher than 45 cm/h^{-1} (**Figure 11**). Basing on these results, it was deduced that infiltration values in the study area vary greatly between rapid and very rapid. They also vary with slope characteristics including gradient and curvature as well as land use and cover properties. Following the experiments conducted, it was concluded that the steady state water infiltration values in the study area range from 12.2 cm h^{-1} to 88.5 cm h^{-1} .

Soil water infiltration was noted to vary across slope position and topographic configuration. Whereas upper slope sections and spur slopes with shallow soils experience low infiltration rates, lower slope sections and topographic hollows with deeper soils are associated with high infiltration rates. This variation in infiltration rates also signifies differences in soil saturation levels (“For example, see [47]”). The lower slope sections are associated with greater saturation rates which result into saturation overland flow processes. Along the topographic slope elements, the saturation overland flow incrementally moves upslope from the slope base [48]. Materials along topographic hollows remain saturated most times due to greater clay content dominated by illite/muscovite minerals. This phenomenon leads to decreased soil material strength along the topographic hollows, inducing landslide occurrence. Equally noticed in this study was a relationship between topographic characteristics and soil water infiltration. Greater soil-water infiltration values are experienced along topographic hollows and lower slope elements than the spurs and upper sections. Such variations in infiltration values in relation to topographic characteristics are associated with differences in soil depth along the slope configurations. This study, therefore, approves that using the soil-water infiltration experiments along different slope sections and gradients it is possible to predict landslide occurrence.
